INVESTIGATION OF BACTERIAL MORTAR FOR SUSTAINABLE STRUCTURAL REPAIR APPLICATIONS

Panem Said basha

DOI Link: <https://doi.org/10.64971/j.cph.eijtem.v13.i2.23.2026>

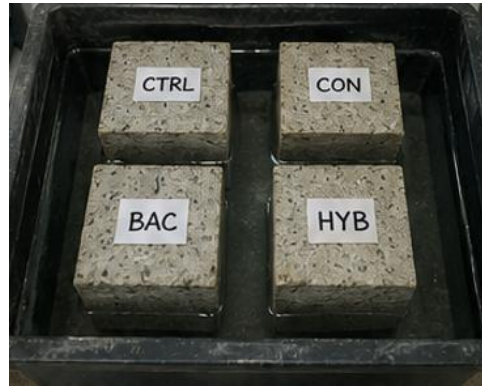
Figure 2 Cube Specimens immersed in water

This test gauges the durability of concrete by measuring how much water it absorbs. After 24 hours of drying at $105 \pm 5^\circ\text{C}$, 150 mm cube specimens were immersed in clean water for an additional 24 hours. The formula

where W1 is the dry weight and W2 is the wet weight, was used to determine the percentage of water absorption. Because calcium carbonate precipitation sealed microcracks, specimens treated with bacterial mortar exhibited reduced water absorption, increasing their impermeability.

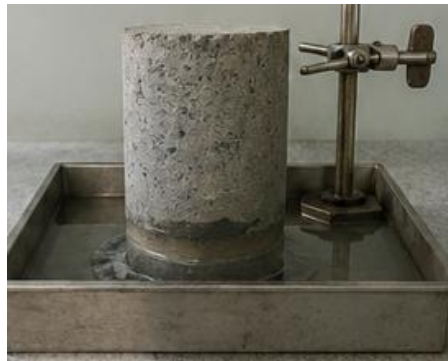
Figure 3 Sorptivity test

The rate of capillary water absorption is measured using the Sorptivity Test. A shallow water level was used to submerge cylindrical specimens that had been dried to a consistent weight and sealed on all but one round face. At predetermined intervals, mass increase was measured. Bacterial mortar-repaired specimens had lower sorptivity values, which indicate fewer capillary pores and increased durability.

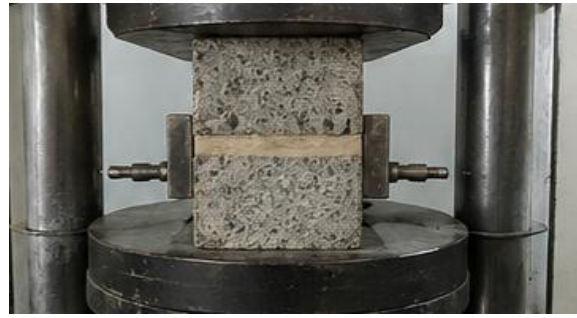
Figure 5 Bond Strength Testing

The Bond Strength Test evaluates how well repair mortar adheres to concrete. Various mortars were used to fix cracked concrete cubes, and compressive force was used until the cubes failed. The failure load was divided by the bonded area to determine the bond strength. Because calcium carbonate precipitation increased interfacial bonding and reduced weak zones, bacterial mortar demonstrated improved bonding.

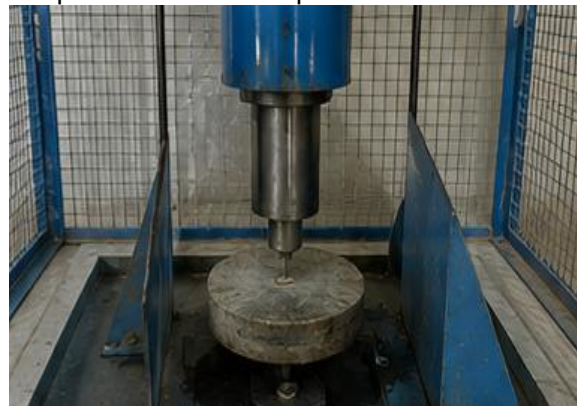
Figure 6 Impact Resistance Testing

This test assesses how resilient concrete is against abrupt loads. A hammer dropped from a predetermined height was used to strike disc specimens, and the number of strikes required before failure was recorded. Better toughness was indicated by higher counts. Because internal calcite deposition sealed fissures, specimens restored with bacterial mortar successfully absorbed energy and demonstrated superior impact resistance compared to conventional mortars.

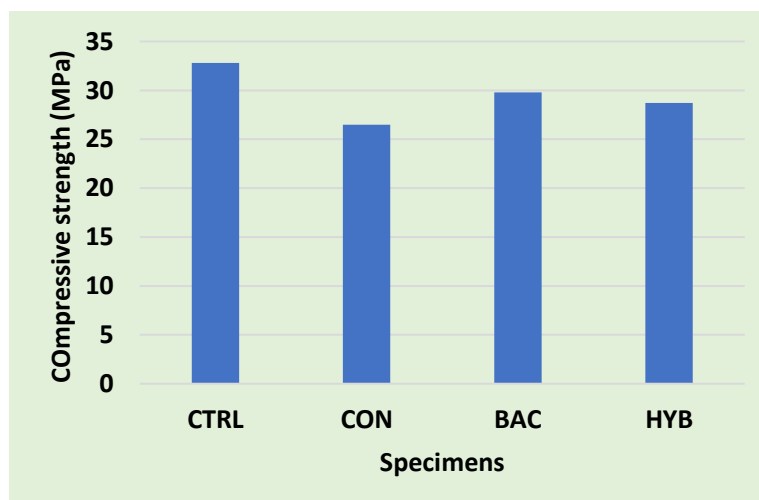
Figure 7 Compressive strength results

The experimental results comparing conventional repair mortar, bacterial mortar, and hybrid repair solutions for cracked concrete members are presented in this chapter with a focus on crack healing, durability, and strength recovery. As a baseline, the control specimen's average compressive strength was 32.8 MPa. The strength recovery of repaired specimens varied; conventional repairs only reached 80.8% recovery, whereas bacterial mortar showed a recovery of 90.9%, which was attributable to calcium carbonate precipitation.

- Bacterial mortar outperformed conventional mortar in terms of compressive strength, reaching 29.8 MPa (about 90.9% recovery) as opposed to 26.5 MPa (80.8% recovery).

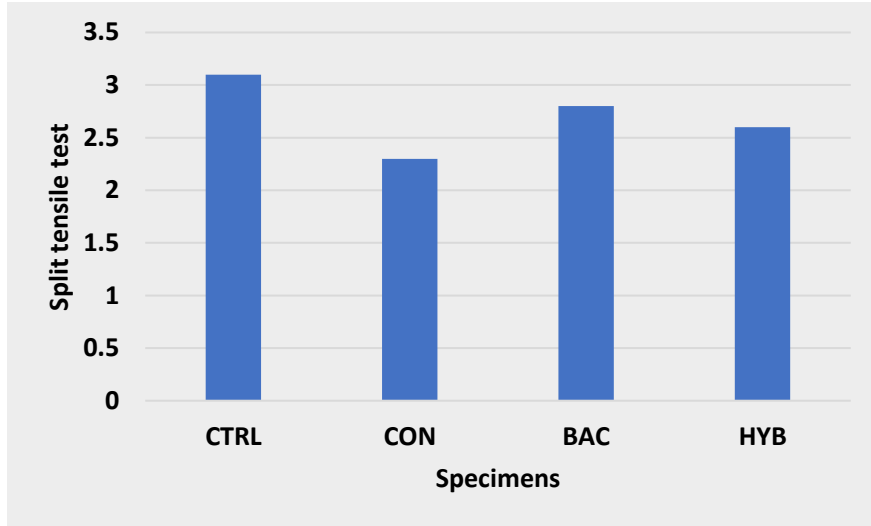
Figure 8 Split tensile strength results

Conventional specimens attained 74.2% of control strength in split tensile strength, while bacterial repairs restored approximately 90.3% because of improved bonding from calcium carbonate. The recovery rate from hybrid repairs was 83.9%. Conventional repairs only achieved 76.1% of control in flexural strength testing, whereas bacterial mortar recovered 91.3%, demonstrating its efficacy in controlling tensile stresses.

- Better bonding and crack resistance were demonstrated by the split tensile strength of bacterially repaired specimens, which was 2.8 MPa as opposed to 2.3 MPa for traditional mortar. Furthermore, bacterial mortar had a flexural strength of 4.2 MPa, which was greater than conventional mortar's 3.5 MPa.

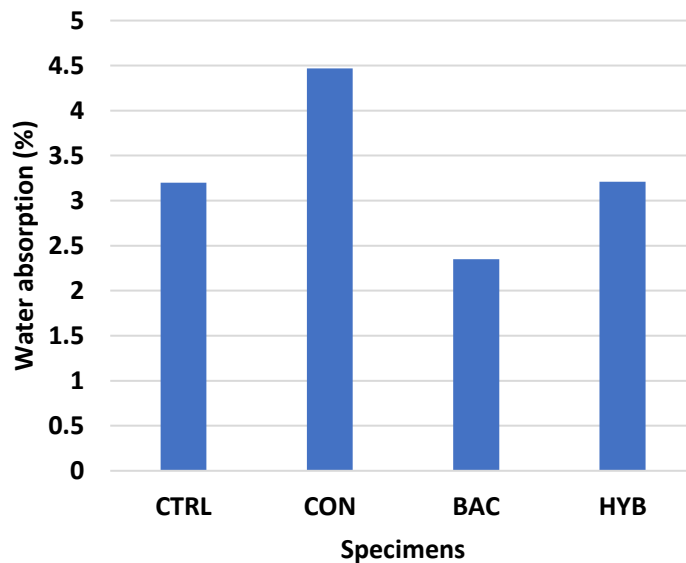
Figure 9 Water absorption test results

Evaluations of crack width revealed an 83% decrease with bacterial mortar as opposed to 38% with traditional techniques. This type of treatment showed improved durability in addition to successfully sealing cracks. According to water absorption studies, bacterial repairs improved impermeability by absorbing only 2.35% of water, which is significantly less than the 4.47% of conventional repairs.

- Conventional mortar only achieved about 38% reduction in crack width, whereas bacterial mortar achieved over 80%.
- The water absorption rate decreased from 4.47% for standard mortar to 2.35% for specimens treated with bacteria, indicating improved impermeability and decreased pore connectivity.

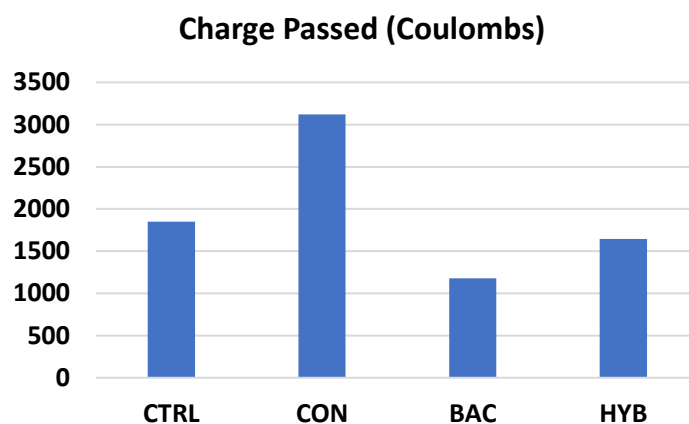
Figure 11 RCPT results

The RCPT was used in the study to assess the resistance of repaired concrete to chloride ion intrusion. The findings showed that lower charge passing values were correlated with increased durability against reinforcement corrosion. Because of its open microcracks and porous zones, conventional repair mortar exhibited the greatest charge passing value of 3120 Coulombs, indicating considerable chloride permeability. The specimens that were repaired using bacterial mortar, on the other hand, had the lowest value of 1180 Coulombs, indicating exceptionally low chloride permeability since the chloride pathways were well blocked and the matrix density was increased by the precipitation of bacterial calcite. With a charge passing value of 1645 Coulombs, the hybrid repair system, which benefits from mechanical bonding and bacterial healing, also showed significant gains. Overall, the results highlight bacterial mortar's higher resistance to chloride intrusion.

- The RCPT revealed significant variations in permeability: bacterial repairs produced 1180 Coulombs, indicating lower chloride permeability, while conventional repairs produced 3120 Coulombs.
